# Arborist Assessment Report

Tamworth Regional Council

PROJECT DSJN1429

Site Address: King George Ave Tamworth

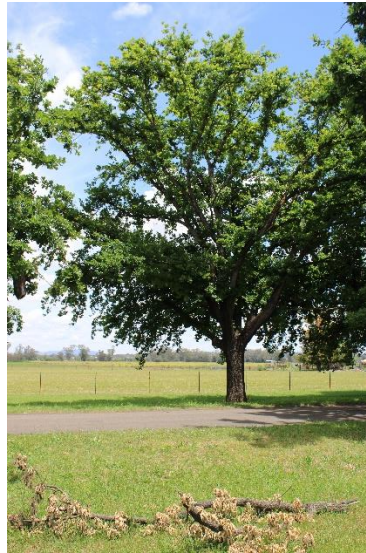
TREE 11

11	531°.11 095 150°.94 743	<i>Quercus robur</i> English Oak	16	60	14	85	Mature moderate condition, epicormic, beam fracture in secondary scaffolding branch 1m length over road. Borers visible in beam fracture.	D2	3.1	7.2	Remediation of deadwood and fractured branch.

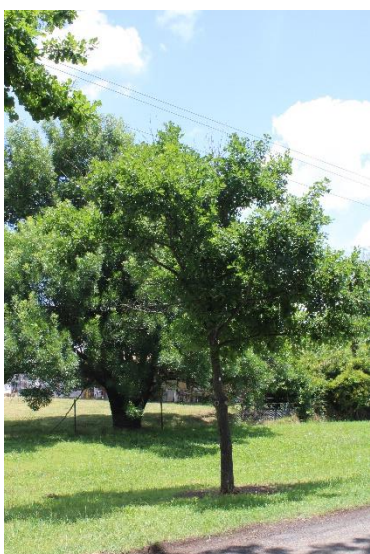
TREE 16

16	S31°.11 048 150°.94 698	<i>Quercus robur</i> English Oak	6	25	4	30	Semi mature Moderate condition damage at base of tree. Bark lifting and dehydrating.	D2	2.0	3.0	Review Annually
17	S31°.11 029 150°.94 681	<i>Quercus robur</i> English Oak	8	30	6	40	Semi mature moderate condition, borer damage at base	D2	2.3	3.6	Review Annually

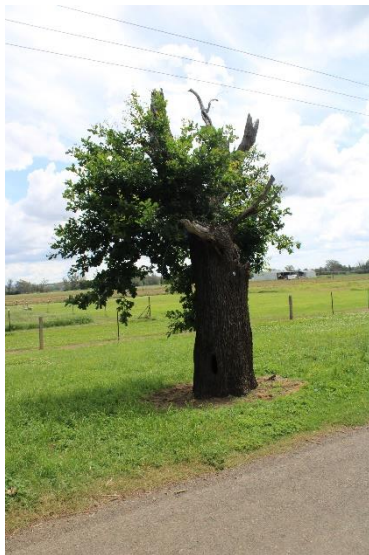
TREE 23

22	S31°.10 844 150°.94 510	Quercus <i>robur</i> English Oak	14	70	12	95	Mature good condition good vigour	A2	3.2	8.4	Review Annually
23	S31°.10 835 150°.94 501	Quercus <i>robur</i> English Oak	5	100	3	130	STAG, Poor Condition significant borer attack and decay.	C4	3.7	12.0	Remove tree and replant

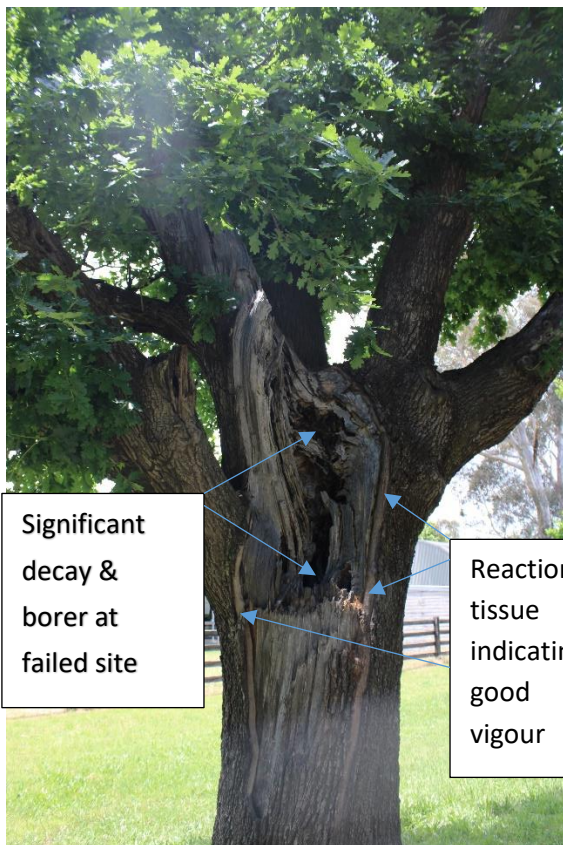
Significant decay & borer at failed site

Reaction tissue indicating good vigour

A/ TYPICAL decay damage failed section leader.

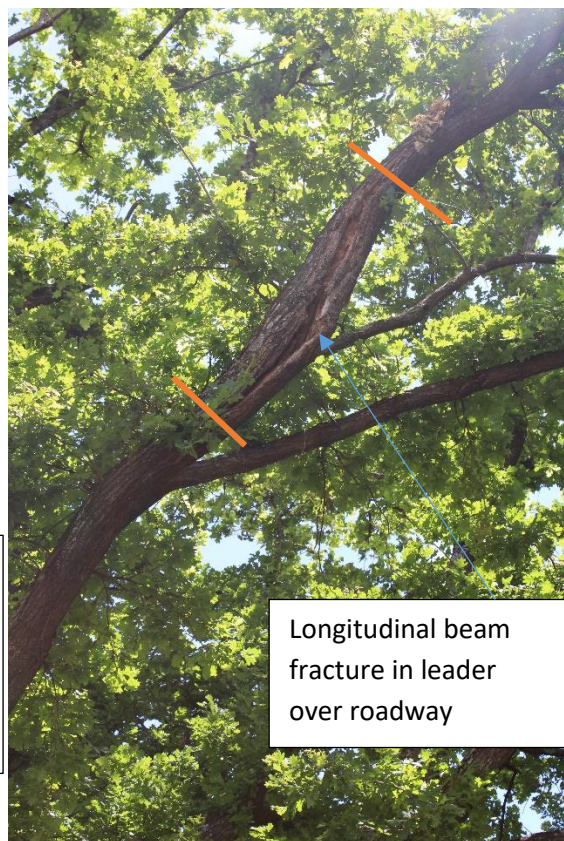
Longitudinal beam fracture in leader over roadway

B/ TREE 11: Significant beam fracture scaffolding

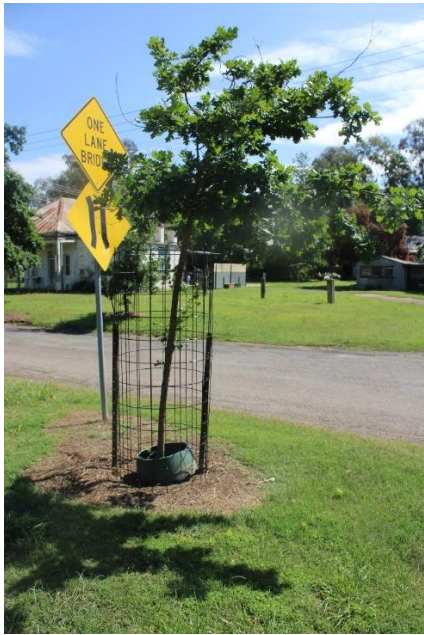
C/ Typical new planting movements

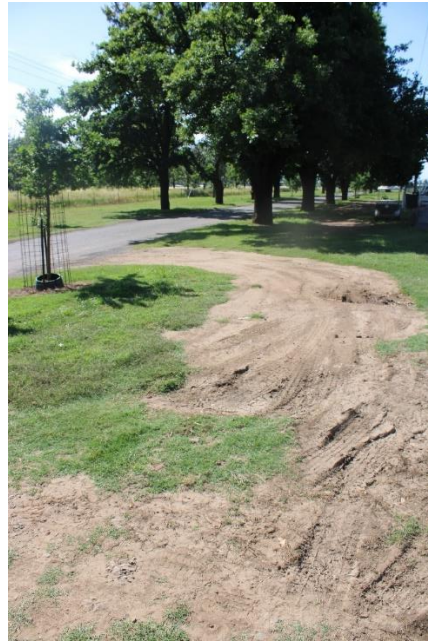
D/ Soil compaction caused by turning traffic

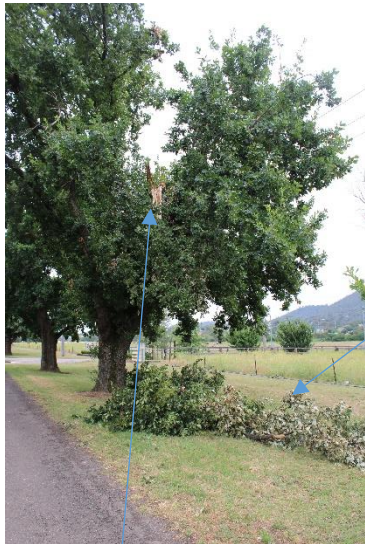
G/ Failure point, section under canopy.

Fallen tree section in drop zone of the tree. Three located on the northern side of avenue.

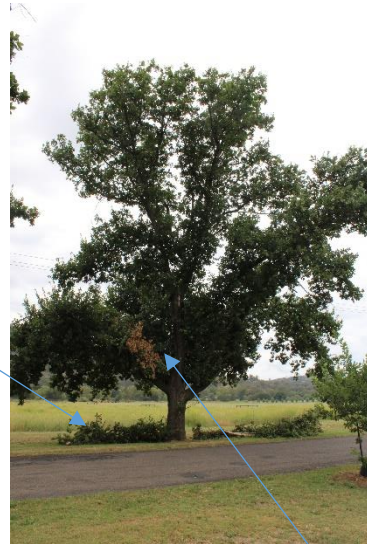
F/ Same tree indicating hanging branch.

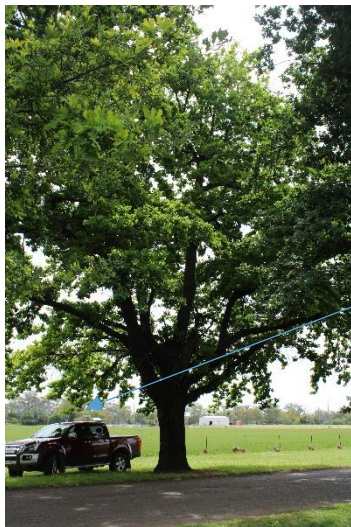
H/ lower scaffolding canopy

Lower canopy height restricted for machinery access.

Lower canopy scaffolding branches (see Photos H & I) clearly indicate the lower canopy heights and potential of increased damage to the trees canopy by machinery.

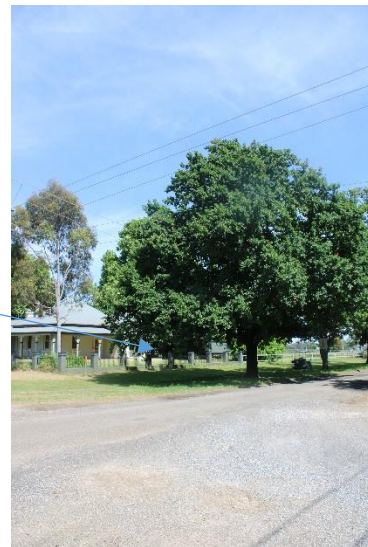
I/ Large low dome canopy typical

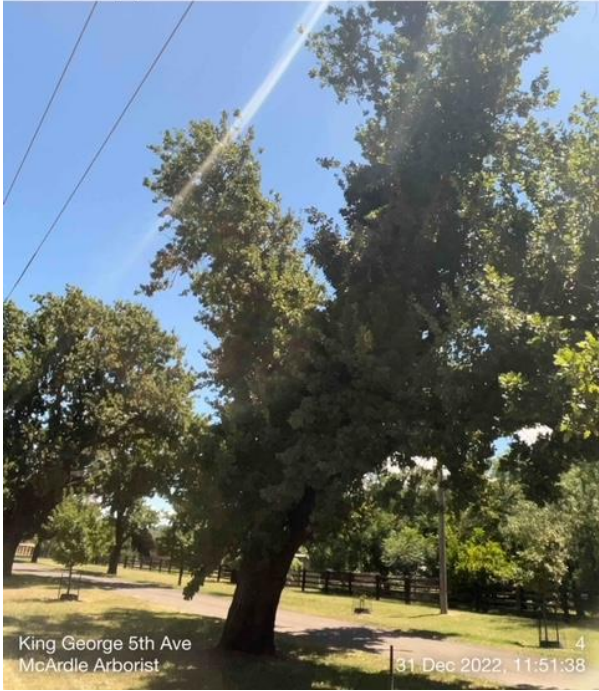
**Plate 1: Tree 4, *Quercus robur* (English Oak).**

<p>King George 5th Ave McArdle Arborist</p> <p>31 Dec 2022, 11:51:38</p>	☉ 354°N (T) LAT: -31.112055 LON: 150.948477 ±3m		
	North	66.07%	26.79%
	South	75.00%	17.86%
	East	75.00%	21.43%
	West	41.07%	55.36%
Mean		64.29%	30.36%

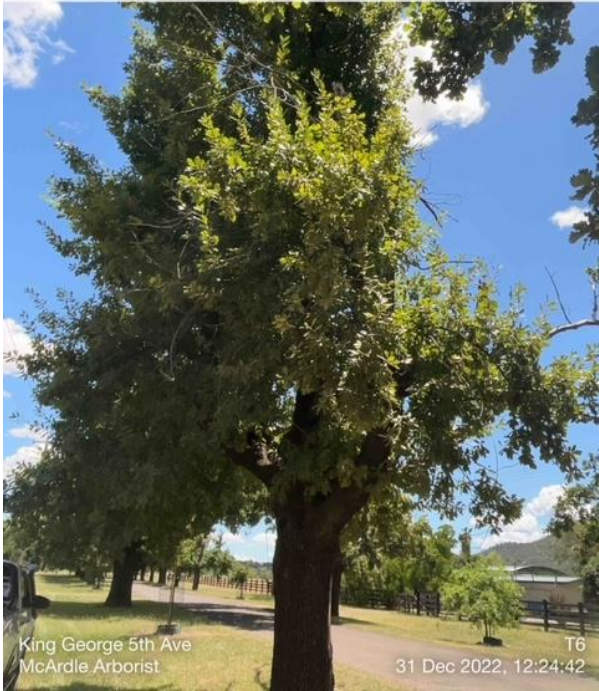
**Plate 2: Tree 6, *Quercus robur* (English Oak).**

<p>King George 5th Ave McArdle Arborist</p> <p>31 Dec 2022, 12:24:42</p>	☉ 334°NW (T) LAT: -31.111600 LON: 150.948342 ±43m		
	North	35.71%	57.14%
	South	44.64%	50.01%
	East	44.64%	49.11%
	West	66.07%	32.14%
Mean		47.77%	47.10%

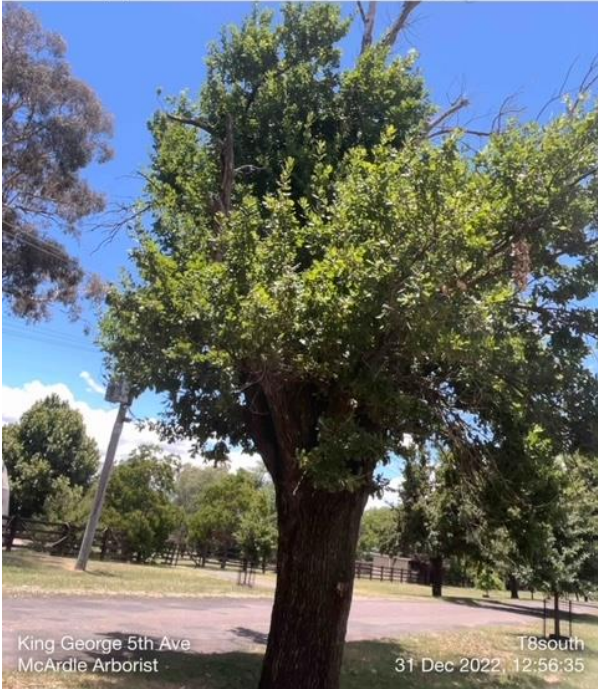
Plate 3: Tree 8, *Quercus robur* (English Oak).

<p>King George 5th Ave McArdle Arborist</p> <p>T8south 31 Dec 2022, 12:56:35</p>	North	41.79%	57.14%
	South	60.36%	37.50%
	East	68.75%	30.36%
	West	56.26%	42.85%
	Mean	56.79%	41.96%

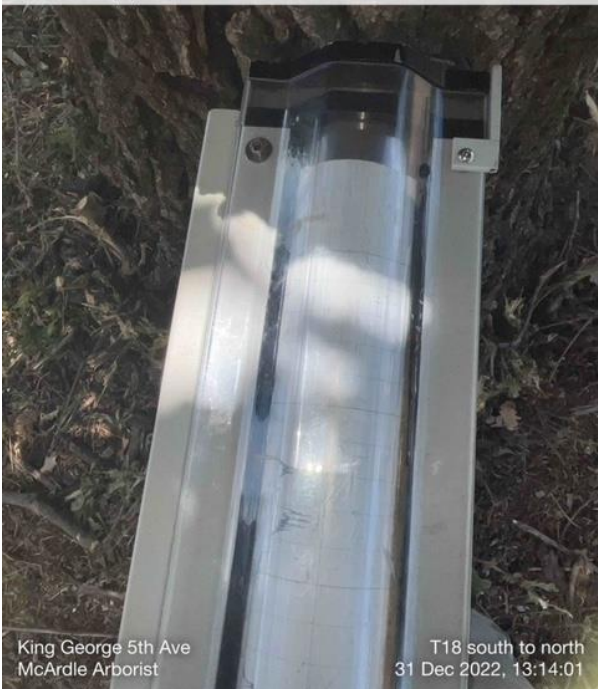
Plate 4: Tree 18, *Quercus robur* (English Oak).

NOTE: Further testing was completed on 30<sup>th</sup> December on 8 identified trees for holding wood, Tree #18 has been identified for removal and replanting, whilst the 7 remaining trees (# 4, 6, 8, 31, 35, 37, and 46) are recommended for re assessment in 2-3 years, with management of the canopy structure by remedial pruning is recommended. (Appendix E)

<p>King George 5th Ave McArdle Arborist</p> <p>T18 south to north 31 Dec 2022, 13:14:01</p>	North	-	-
	South	28.57%	57.13%
	East	-	-
	West	42.86%	50.00%
	Mean	35.72%	53.57%

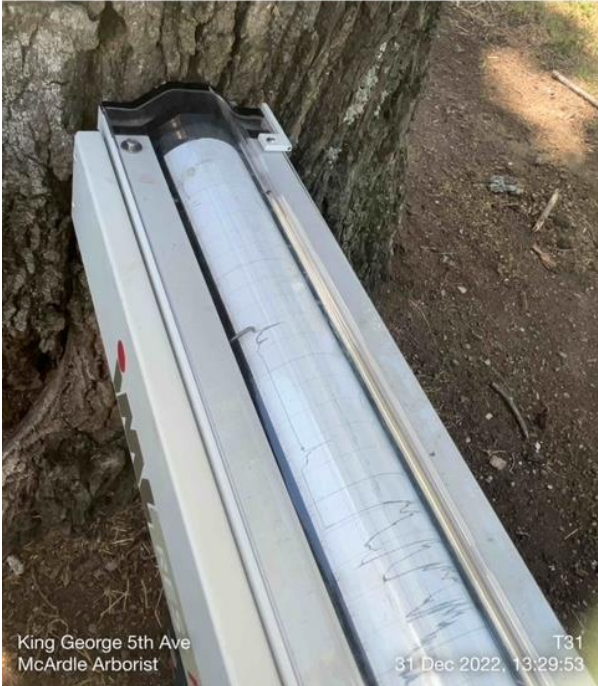
Plate 5: Tree 31, *Quercus robur* (English Oak).

North	-
		South	51.79%
		East	44.65%
		West	64.29%
King George 5th Ave McArdle Arborist T31 31 Dec 2022, 13:29:53		Mean	53.58%
			44.04%

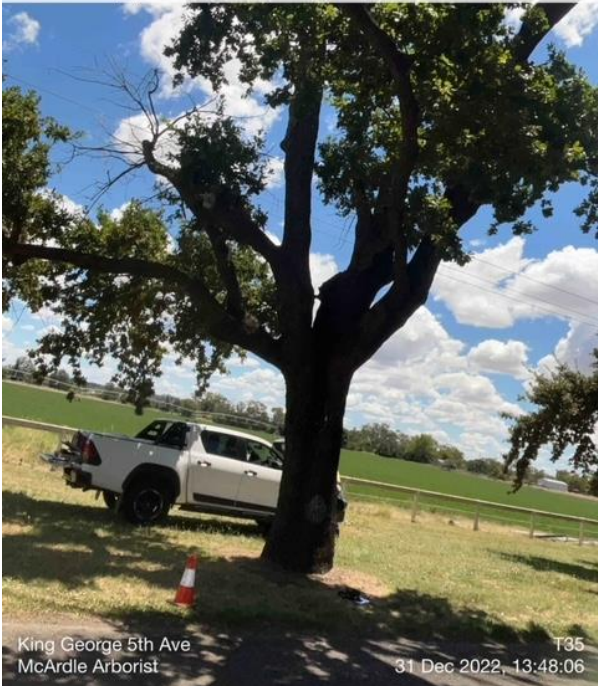
Plate 6: Tree 35, *Quercus robur* (English Oak).

North	73.21%
		South	58.04%
		East	90.18%
		West	36.61%
King George 5th Ave McArdle Arborist T35 31 Dec 2022, 13:48:06		Mean	64.51%
			30.80%

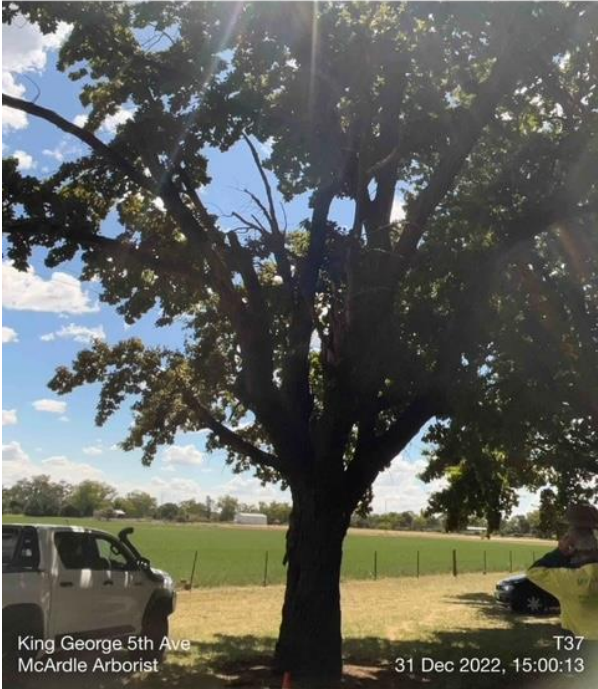
*Plate 7: Tree 37, Quercus robur (English Oak).*

<div>           King George 5th Ave McArdle Arborist         </div> <div>           T37 31 Dec 2022, 15:00:13         </div>		Sound Wood	Cavities & Decay
	North	67.85%	26.79%
	South	60.72%	35.71%
	East	42.86%	55.35%
	West	59.43%	37.00%
	Mean	57.72%	38.71%

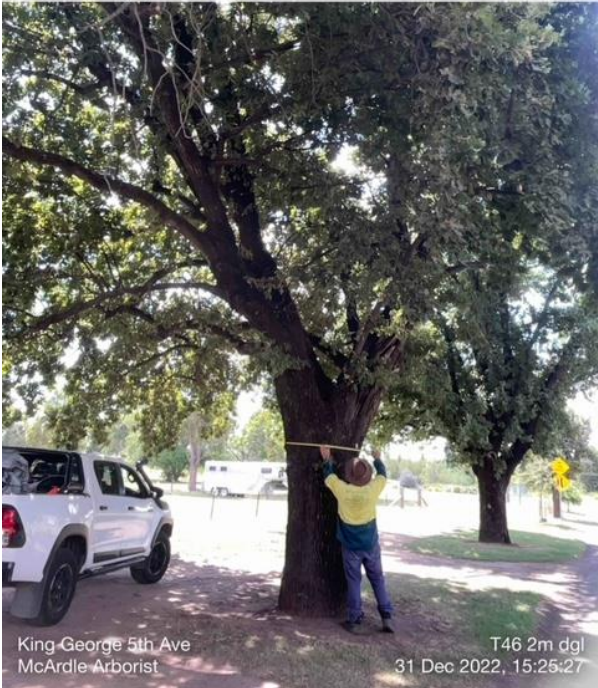
*Plate 8: Tree 46, Quercus robur (English Oak).*

<div>           King George 5th Ave McArdle Arborist         </div> <div>           T46 2m dgl 31 Dec 2022, 15:25:27         </div>		Sound Wood	Cavities & Decay
	North	41.96%	51.79%
	South	40.18%	58.04%
	East	79.46%	17.86%
	West	70.54%	27.68%
	Mean	58.04%	38.89%
