# Arborist Assessment Report

Tamworth Regional Council

PROJECT DSJN1429

Site Address: King George Ave Tamworth

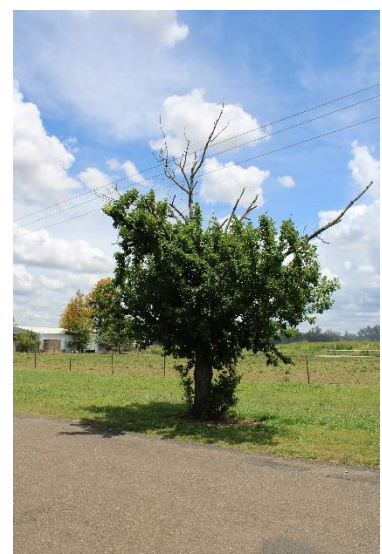
TREE 18

NOTE: Further testing was completed on 30<sup>th</sup> December on 8 identified trees for holding wood, Tree #18 has been identified for removal and replanting, whilst the 7 remaining trees (# 4, 6, 8, 31, 35, 37, and 46) are recommended for re assessment in 2-3 years, with management of the canopy structure by remedial pruning is recommended. (Appendix E)

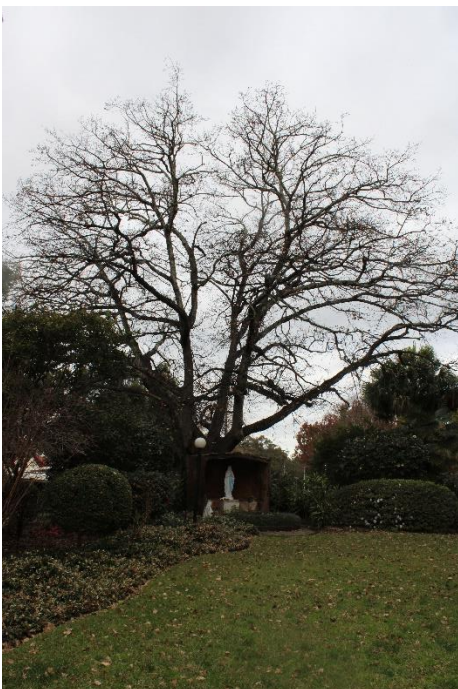
E/ *Q. robur* Loreto Normanhurst Planted 1892

(Above E & F Photos Loreto *Q. robur* Circa 2014 McArdle & Sons maintaining this tree since 1963)

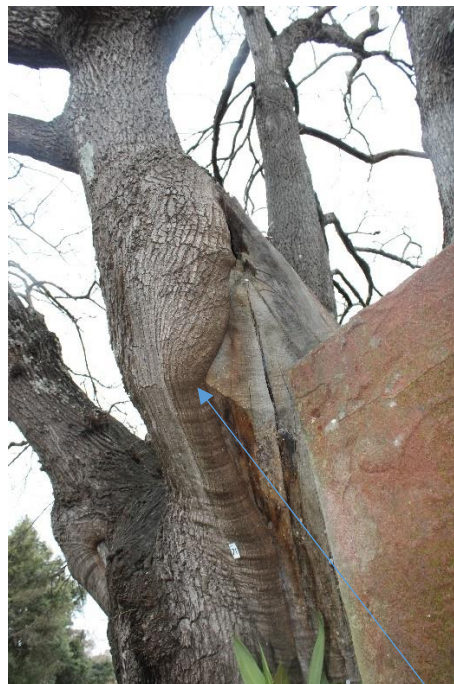
F/ Loreto Normanhurst active wound tissue.

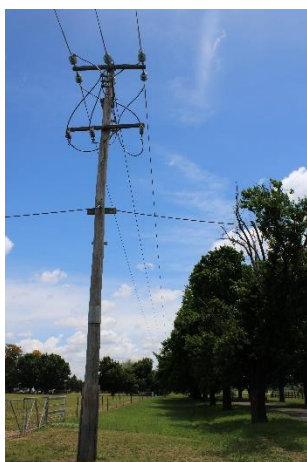
J/ Power pole alignment.

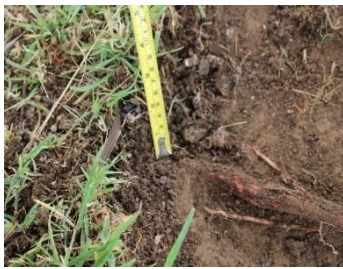
TREE 22 @ 4m

<b>TREE #</b>	<b>1<sup>st</sup> Distance from centre of tree(m).</b>	<b>COMMENTS Hand excavation to 200mm depth (50mm Organic layer not included)</b>	<b>2<sup>nd</sup> Distance from centre of tree(m)</b>	<b>COMMENTS Hand excavation to 200mm depth (50mm Organic layer not included)</b>
5	4	Feeder roots less than 5 mm $\phi$ @ 50mm depth	6	Feeder roots less than 5 mm $\phi$ @ 140mm depth
13	4	Feeder roots less than 5 mm $\phi$ @ 110mm depth	6	Feeder roots less than 5 mm $\phi$ @ 140mm depth
22	4	Feeder roots less than 20mm $\phi$ @ 40mm depth	6	Feeder roots less than 20mm $\phi$ @ 130mm depth
29	4	Feeder roots less than 5 mm $\phi$ @ 50mm depth	6	Feeder roots less than 5mm $\phi$ @ 50mm depth
33	4	Feeder roots less than 10mm $\phi$ @ 75 mm depth	6	Feeder roots less than 15mm $\phi$ @ 80mm depth
36	4	Feeder roots less than 10mm $\phi$ @ 70mm depth	6	Feeder roots less than 50mm $\phi$ @ 200mm depth
38	4	Feeder roots less than 10mm $\phi$ @ 130mm depth	6	Feeder less than 50mm $\phi$ @ 170mm depth

Typical test site TREE 22  
4 & 6m distance from  
the tree centre,  
displaying typical feeder  
roots.
