# Path Material Options

## Calala to CBD Recreational Path

DSJN1429-REP03

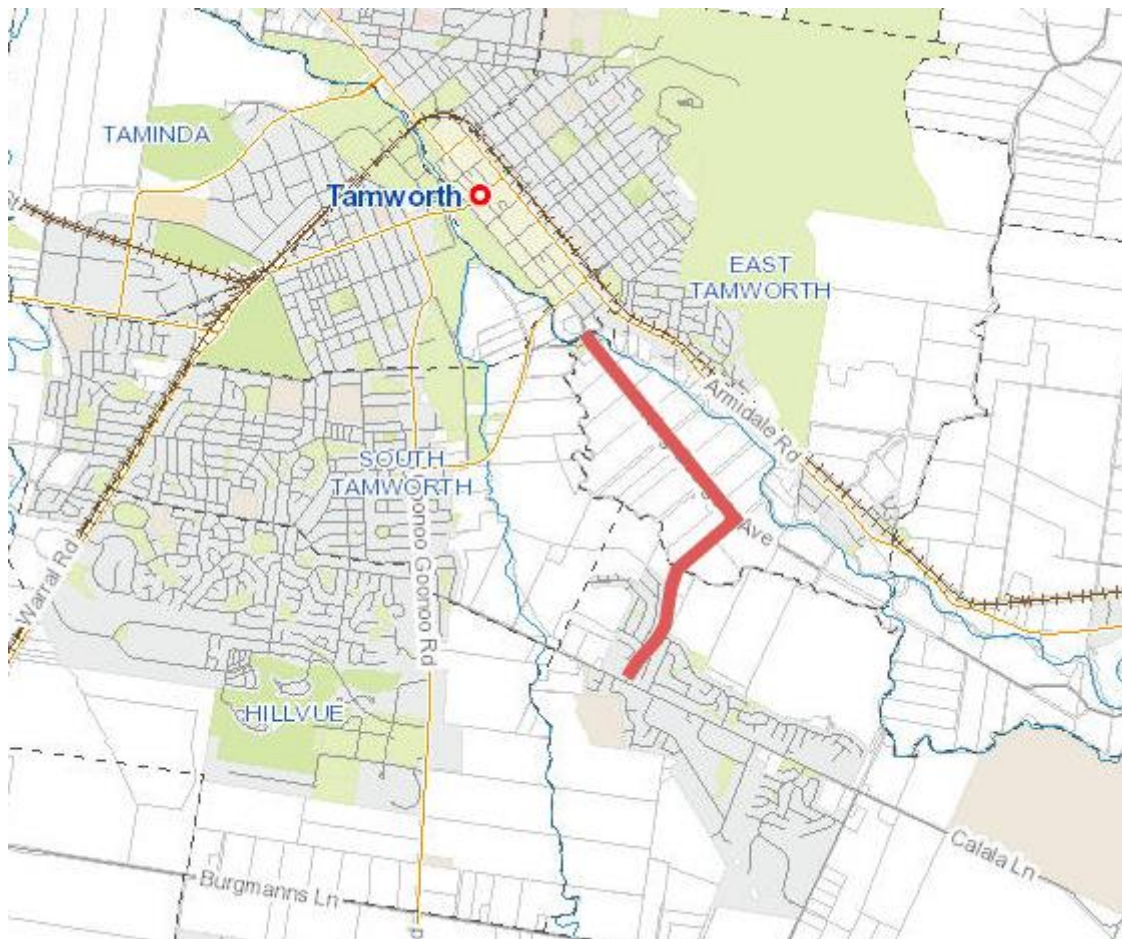
Figure 1 Site plan

The project commences at Paradise Bridge and continues along King George V Avenue and Campbell Road (both the unformed and formed Road Reserves) and finishes at the recently constructed Roundabout at the intersection of Calala Lane and Campbell Road. The proposed path is approximately 3700 metres long.
